Geotechnical Study on Ground and Masonry Structures in Angkorfor Safeguarding Monuments( Dissertation\_全文 )

Iwasaki, Yoshinori

2001-11-26

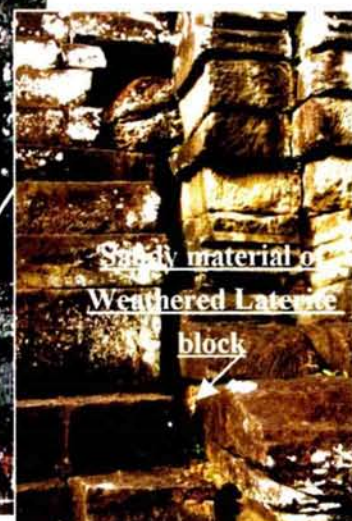
Photo.8-6 South-west corner of the foundation

Ends of both sides are found to have deformed extensively outwards. Careful inspections of the basement of the platform have revealed that there is little uneven settlement at the bottom line of the foundation.

At the west and south corner of the South Library, we could see the outcome of sandy materials from weathered lateritic blocks from a large opening between blocks.

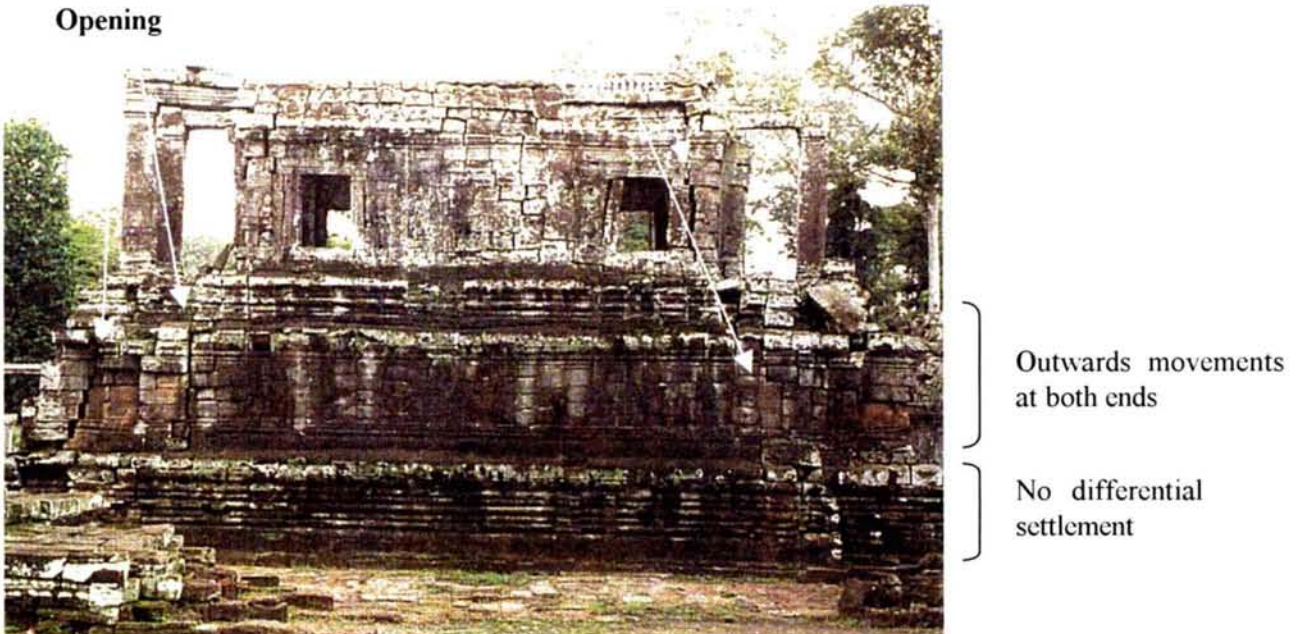
Photo 8-7 North Library, Bayon, side view from south

In Fig.8-7 and 8-8, several large vertical openings are found at the corner of North Library as well South Library.

Most stone elements covering the corner surface of the foundation are found slid outwards. These movements are caused not by the settlement of soil-foundation but by some deformations of the retaining foundation and/or movement of stones themselves.

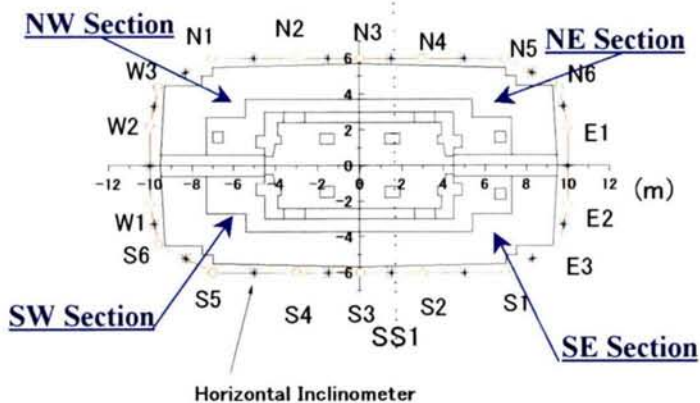
Fig.8-7 Horizontal Inclinator at North Library Bayon

The final heaving was calculated relative to a reference point of  $S_0$ . The maximum heave was observed at south-east corner as 1.8mm and the maximum relative settlement was estimated at N3 point as -0.6mm. These resulted in the maximum uneven heave as 2.4mm.

The uneven heave may be due to uneven unloading against the foundation area of 11m×17.5m or different characteristics of the underground conditions. We can divide the foundation area into four zones of south east, north east, north west, and south west part (see Fig8-7). The estimated unload values among four different zones from 0.36 to 0.39tonf/m<sup>2</sup>.

It was also recognized that the heave of about 2mm at south east corner compared to northwest one. The averaged inclination due to dismantling was about  $2/12000=1/6000$  to southeast direction. The settlement caused by reconstruction process is expected as the same amount. It is expected that the reloading effects on the foundation ground are negligible based upon this observation.

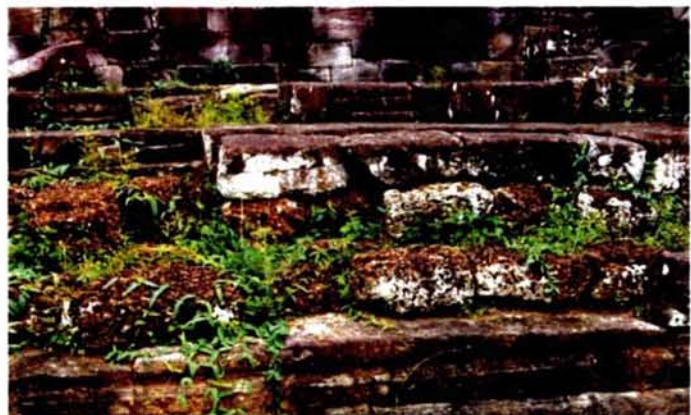
Photo 9-3  
Decayed laterite blocks  
(Foundation of Bayon temple)  
desharpened edges  
and surface weathering

Photo 9-4  
Flow out of decomposed laterite  
(South Library, Bayon Temple)

Typical example in Photo 9-3 is de-sharpened edges of laterite blocks and volume of block is found decreased. It is shown in Photo 9-4 that decomposed laterite block inside the sandstones flows out through an opening between sandstones.
